International Window Cleaning Association

# The Systematic Cleaning and Restoration of Architectural Glass

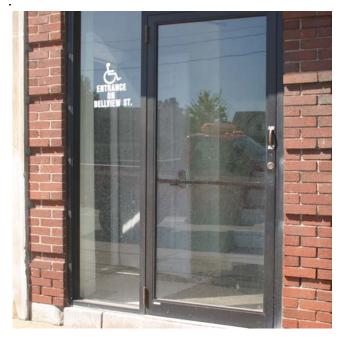
Glass that appears dirty and soiled is often affected by an accumulation of particulates that are characteristic of the everyday environment and not necessarily composed of exotic airborne pollutants. For example, the soiled door shown in Figure 1 exhibits an accumulation of ordinary dust and grime that originated from a relatively commonplace environment.

Figure 1: Entrance door on a municipal building located within 30 feet of a busy roadway.

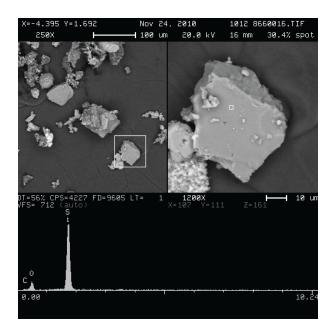
The left hand frame of Figure 3 was taken at a magnification of 250X and reveals the dirty glass of interest to be littered by a variety of irregularly shaped particulates. Many of these measure less than 100 microns in either length or diameter (0.1 millimeters or 4/1000 of an inch). However, more important than size is the chemical composition of the particulates. For example, the right hand frame in Figure 3 focuses on a sharp-edged entity magnified 1200 times for which the compositional analysis reveals the presence of silicon oxide (SiO<sub>2</sub>). In other words, a particle that can be more commonly identified as a grain of sand.

Although small in size, the presence of sand particles is not a trivial matter since  $SiO_2$  is harder than glass and thus has the potential to initiate surface scratches. However, surface scratching is not necessarily a forgone conclusion if particulate removal is undertaken by a skilled window cleaning and maintenance specialist.

Figure 3: Microscopic view of particulates sampled from municipal building entry door which include entities that are composed of silica (sand). Left hand frame shows particles magnified 250 times (250X) while frame on right is shown at 1200X.

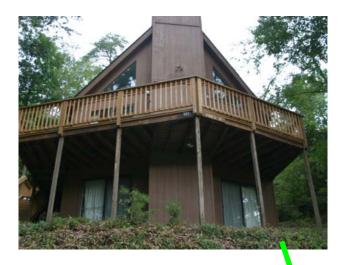
A second example of the accumulation of soils and dust on a window glass installation warrants consideration in order to demonstrate that the results cited in the first example are not necessarily unique. In this instance, attention is focused on the vacation home pictured in Figure 4 which is located in the mountains of northwest Virginia. Here again, as was the case with the municipal building door, some significantly soiled glass can be identified as illustrated in Figure 5.

Fig. 4: Vacation home in the mountains of Virgini

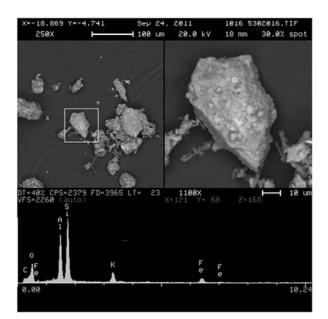
When examined with the aid of a scanning electron microscope, the dust and dirt in this example reveal the interesting physical features that are shown in Figure 6. As in example 1, the observed window dirt is an assembly of numerous irregularly shaped particles that are on the order of 100 microns or less in size.

Compositional analysis in this example also reveals the presence of silicon oxide (sand grains) as well as alumino silicate material which are both harder than commercial flat glass. As a consequence, each of these materials has the potential for initiating surface scratching when removed from a glass surface without the appropriate precautions that are employed by window cleaningprofessionals.

Figure 6: Particulates from Virginia window magnified 1100 times via a scanning electron microscope
